**PRELIMINARY ASSESSMENT/
VISUAL SITE INSPECTION**

**1330 SOUTH KILBOURN AVENUE FACILITY
FORMERLY THE VALSPAR CORPORATION - PAINT
CHICAGO, ILLINOIS**

FINAL REPORT

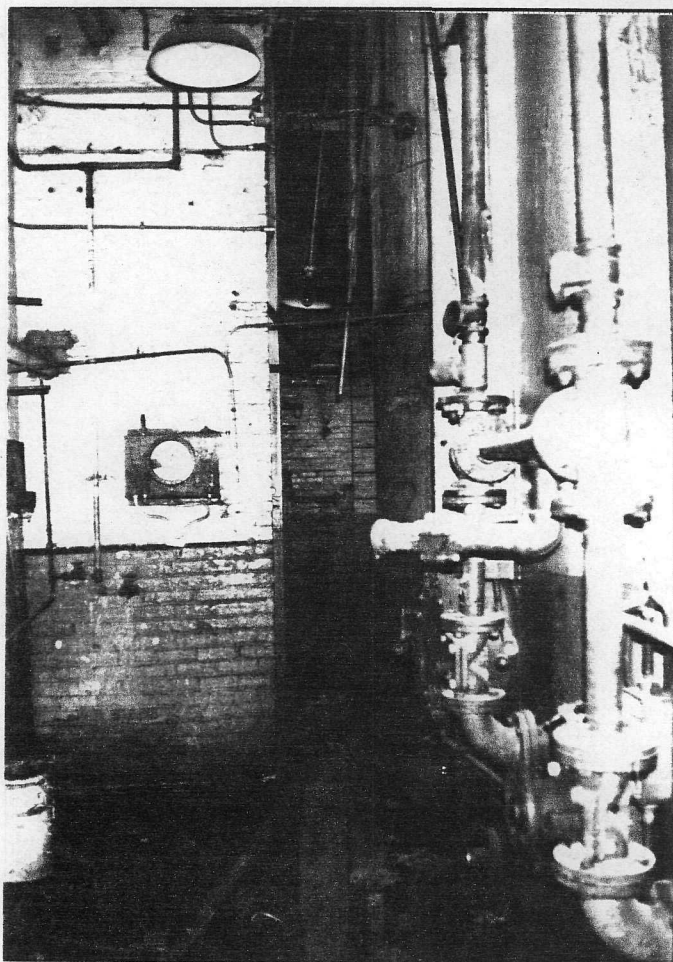
Photograph No.: 10
Location: Building 15-B
Orientation: East
Date: 07/23/91
Description:

This picture shows the general layout of Building 15-B. Tanks 235 through 239 are located in this building along the south wall. Valspar representatives stated that these tanks were resin tanks during the facility's period of operation.

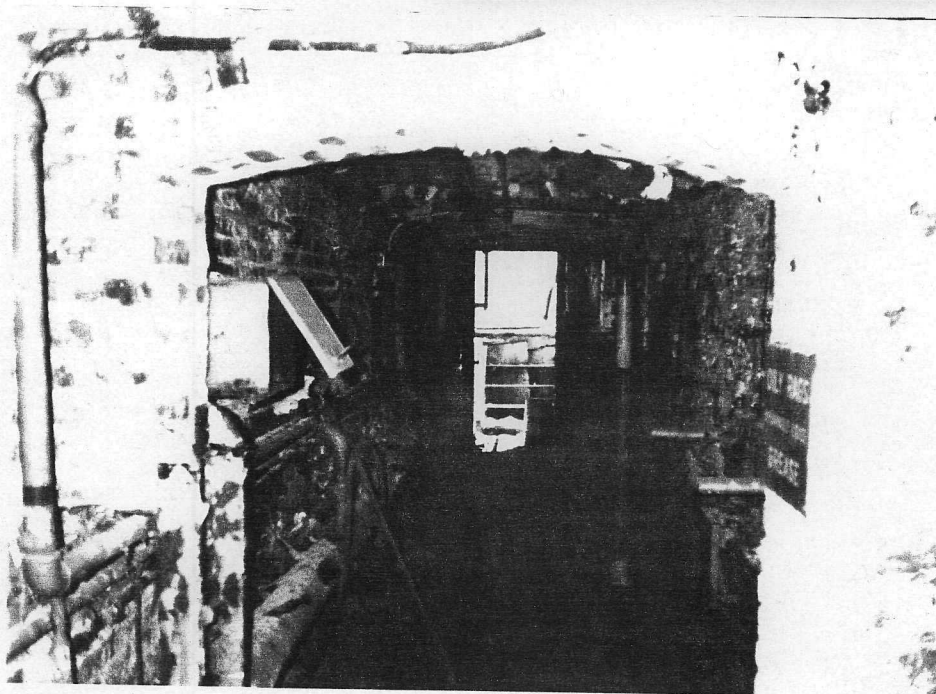
Photograph No. 16
Orientation: East
Description: This picture shows a sunken tunnel beneath Building 15. PRC observed damp areas in the tunnel. An area near the red sign at the right was once used to collect oily rags.

Location: Building 15
Date: 07/23/91

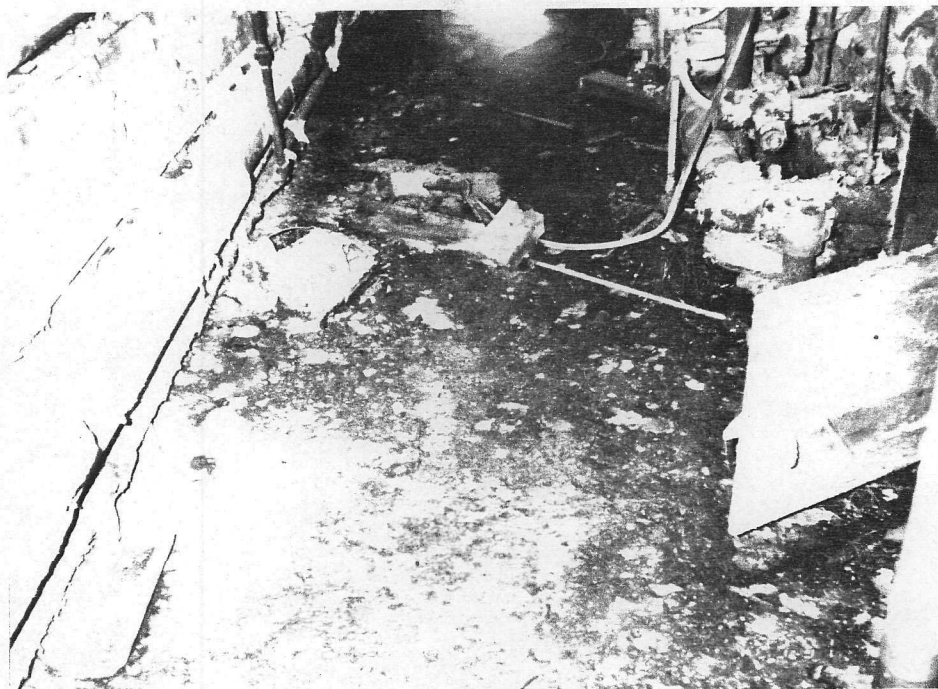
Photograph No. 17

Description: This picture shows a closeup of the floor in the hallway beneath Building 15 (see Photograph No. 16). Note the crumbled piping insulation on the left side of the picture. This insulation may contain asbestos.

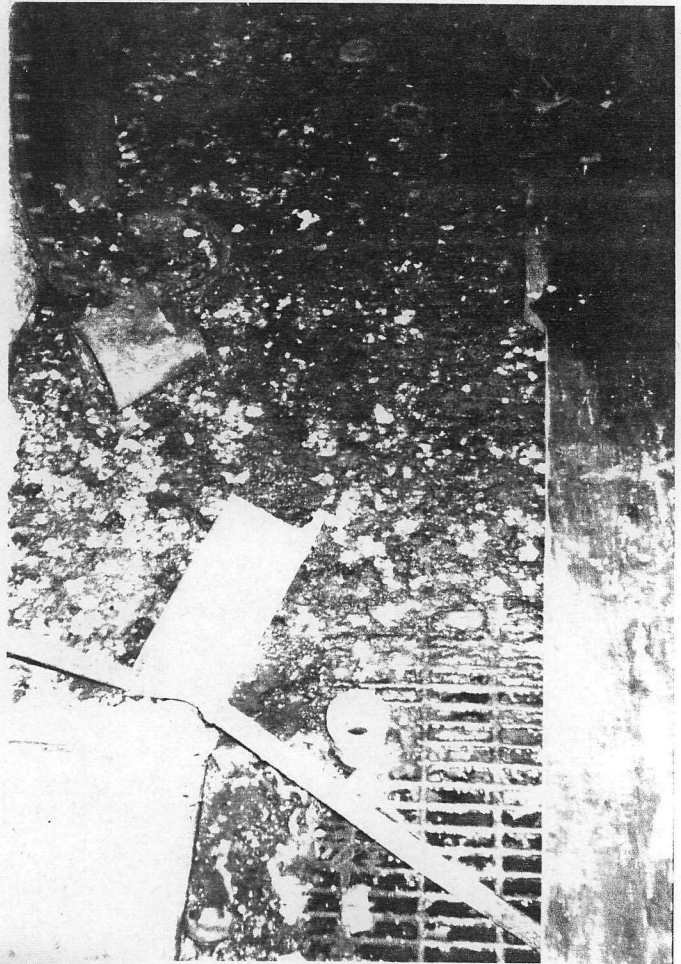
Photograph No. 26
Location: Building 3-F
Orientation: Northeast
Date: 07/23/91
Description:

This picture shows a portion of Building 3-F. The inspection team noted oil stains on the floor near an old transformer. The oil may contain PCBs. The inspection team also noted piping insulation in this building. The insulation may contain asbestos.

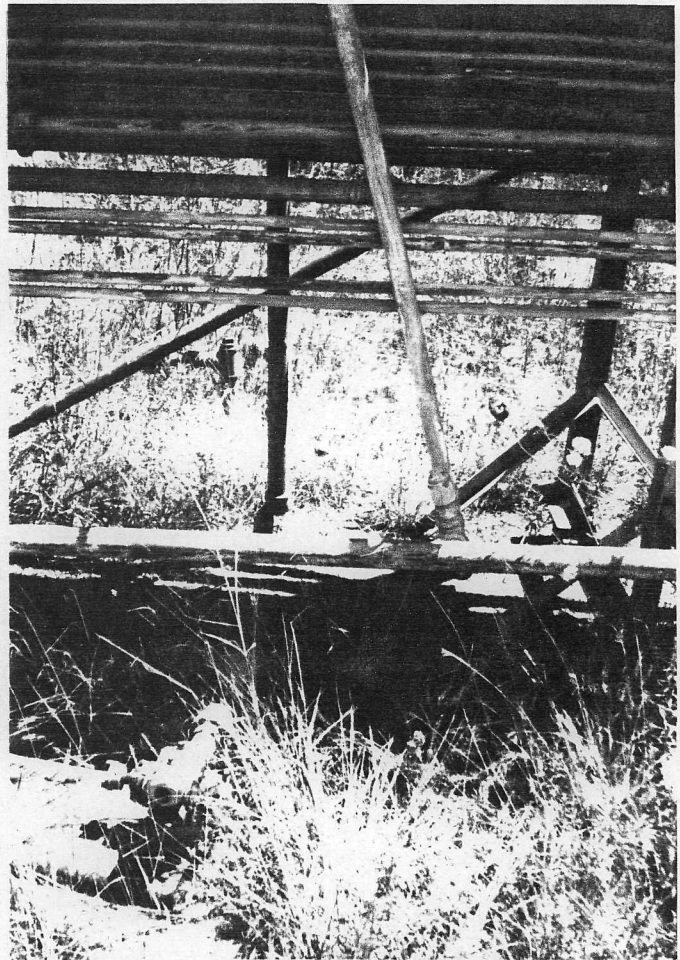
Photograph No. 32
Orientation: North

Location: West lot
Date: 07/23/91

Description: This picture shows the western portion of the facility. At one time, this area contained the superstructures of Buildings 4, 4-A, 4-B, 4-C, 17, 17-A, 21, and 22. These buildings have been demolished, and the lot has been graded with fill over the foundations, which remain.

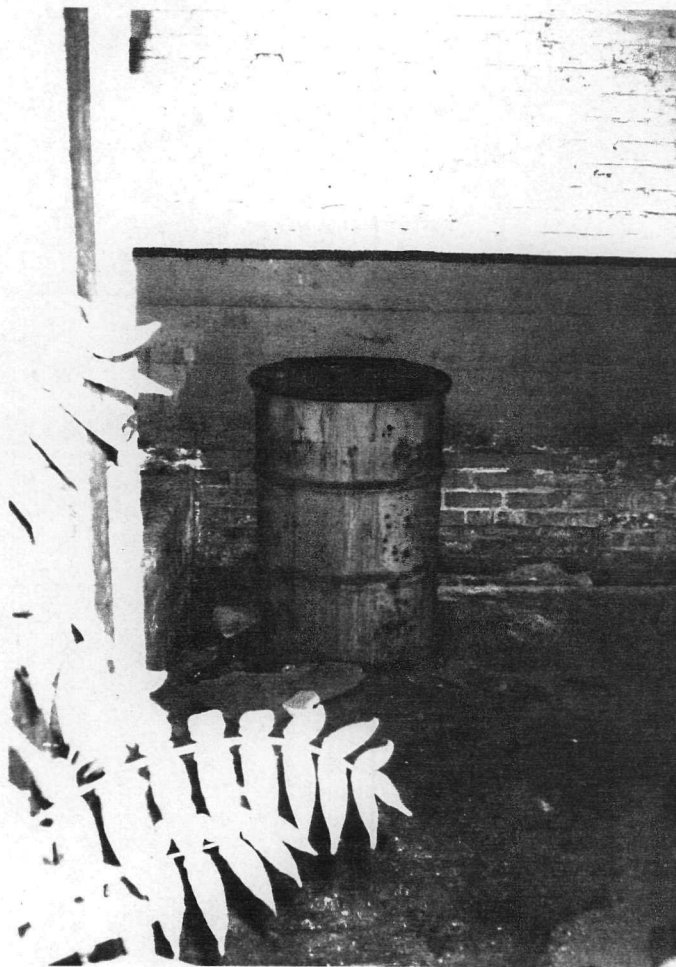
Photograph No. 54

This picture shows one drum located inside Building 5-D. This drum was completely filled with liquid, was loosely covered, and contained volatile constituents. The PID indicated that the drum headspace contained more than 5,000 ppm volatile organics.

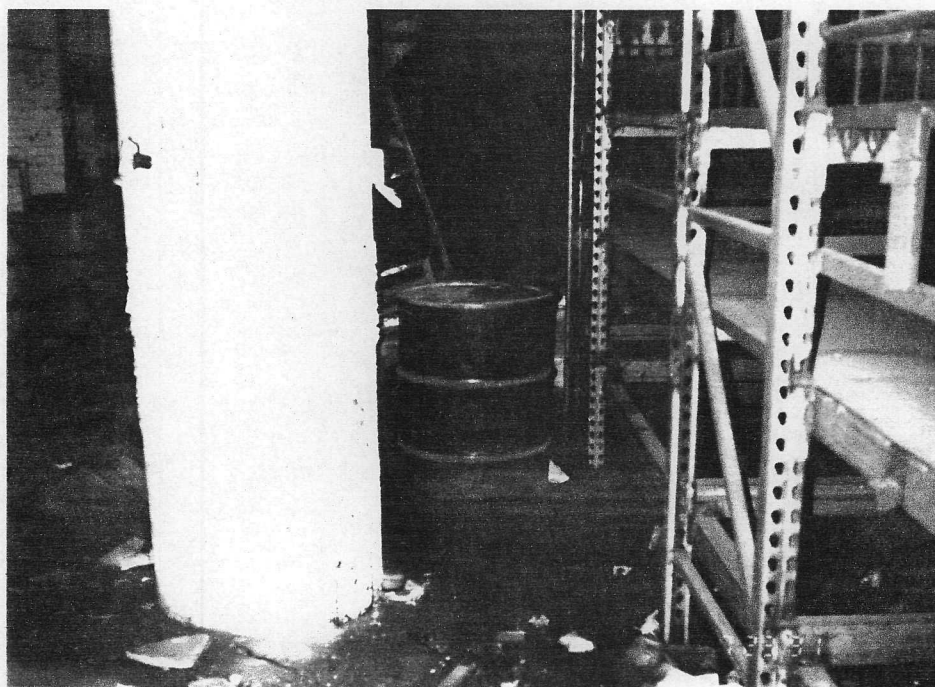
Photograph No. 60

Description: This picture shows a single drum located south of the other six drums in Building 8. This drum contains volatile constituents (headspace readings of 5 ppm were taken). Note that the floor near this drum is stained. The metal racks seen at the right side of the picture indicate that this part of the room may have been used for storage of small containers.

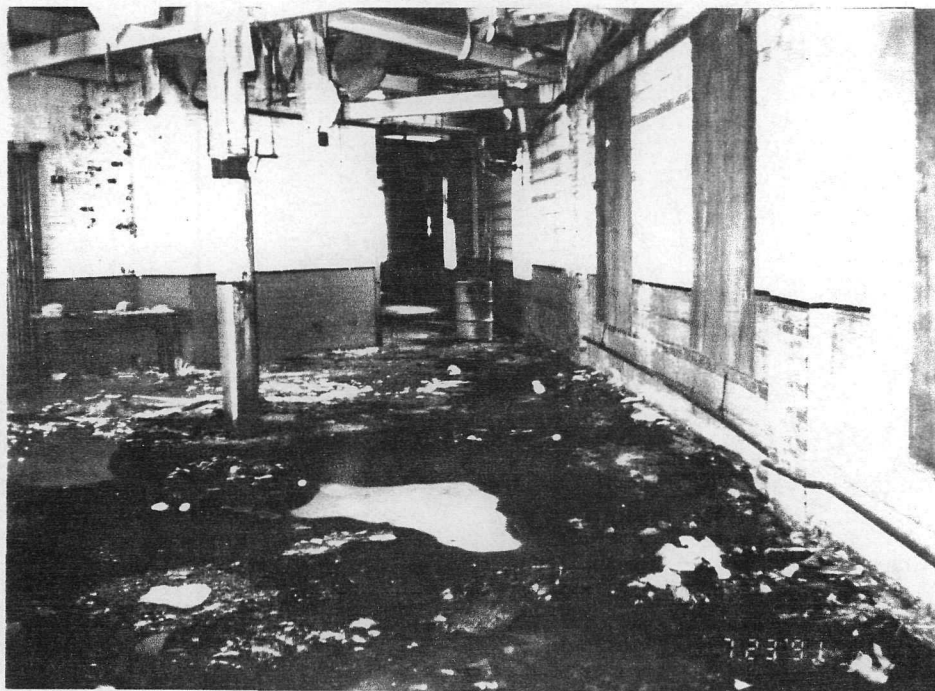
Photograph No. 67

Description: This picture shows one drum located in Building 10-A near the middle of the first floor. The drum contains volatile organics (headspace readings of 3 ppm were taken). Note the amount of liquid and white dust on the floor of this room.

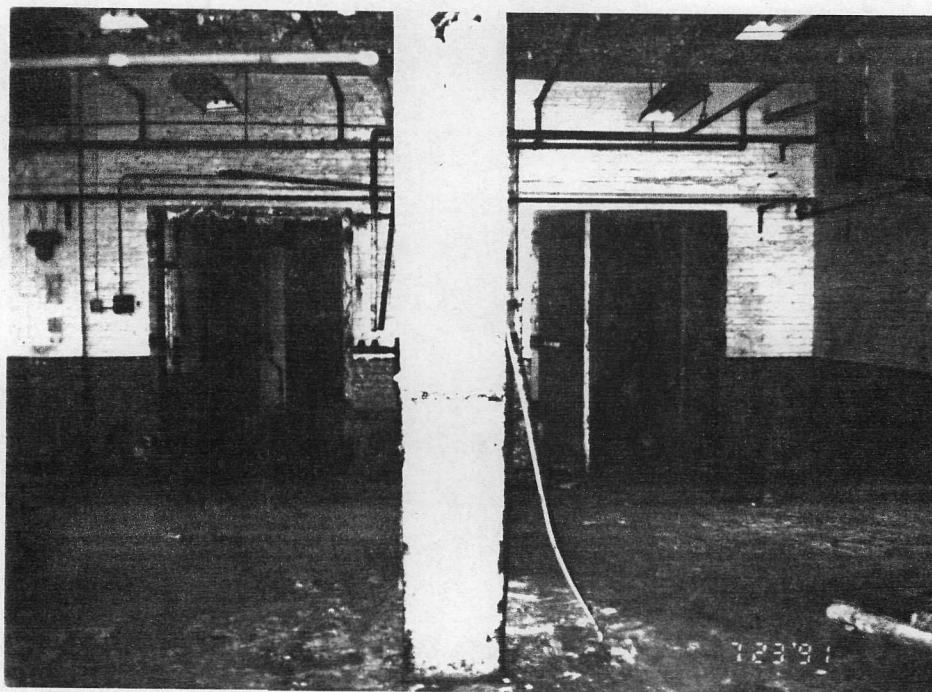
Photograph No. 68

Description: This picture shows Tanks 1, 2, 3, and 4 located on the first floor of Building 10. The tanks are located against the doors in the background. Stairways beneath the tanks were not explored by the inspection team because of safety concerns. Note the white powder on the floor in the right background. Also note the oily stains on the ground near the piping insulation (which may contain asbestos) in the right foreground.

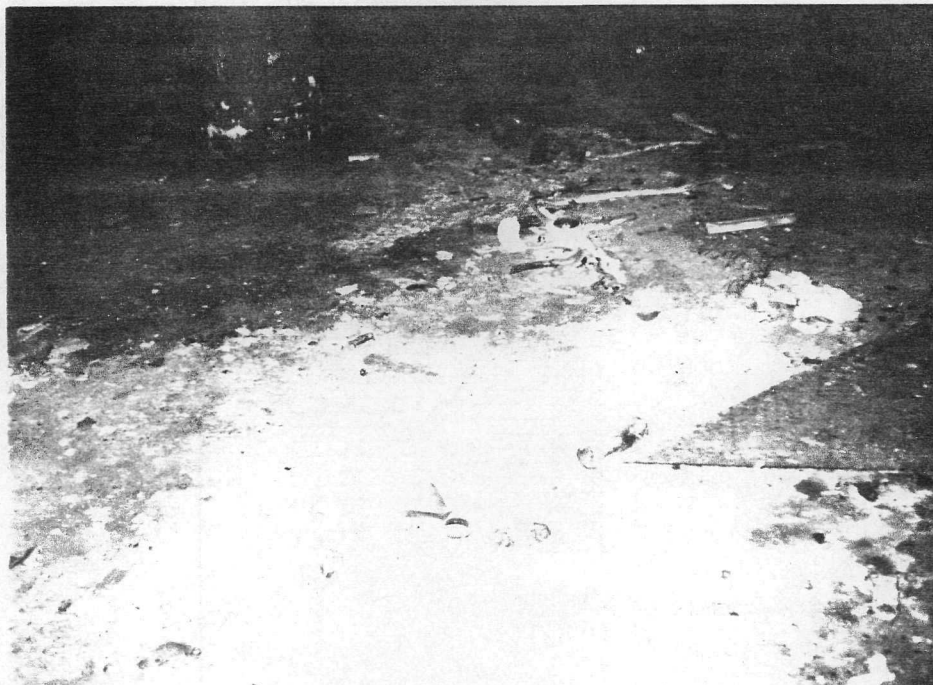
Photograph No. 91

Description: This picture shows the fourth floor of Building 12. Note the various colored paints that have stained the floor in this room. Also note the piping insulation in the right background. The insulation may contain asbestos. The floor in this building was covered with dust and debris.

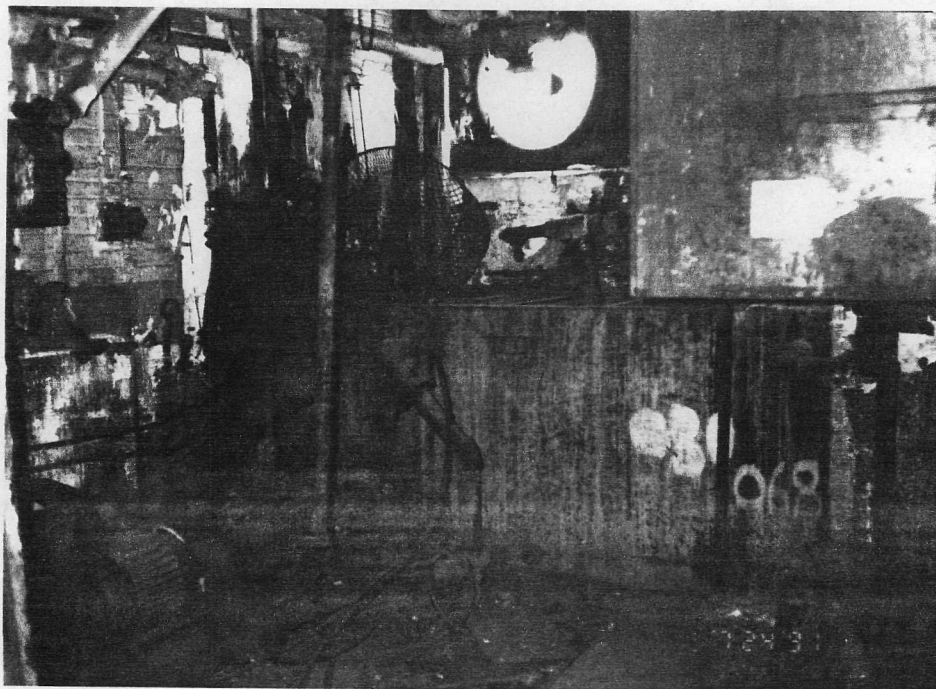
Photograph No. 92

Description: This picture shows Tank 68, located on the fourth floor of Building 12. This tank may have been a parts washer.

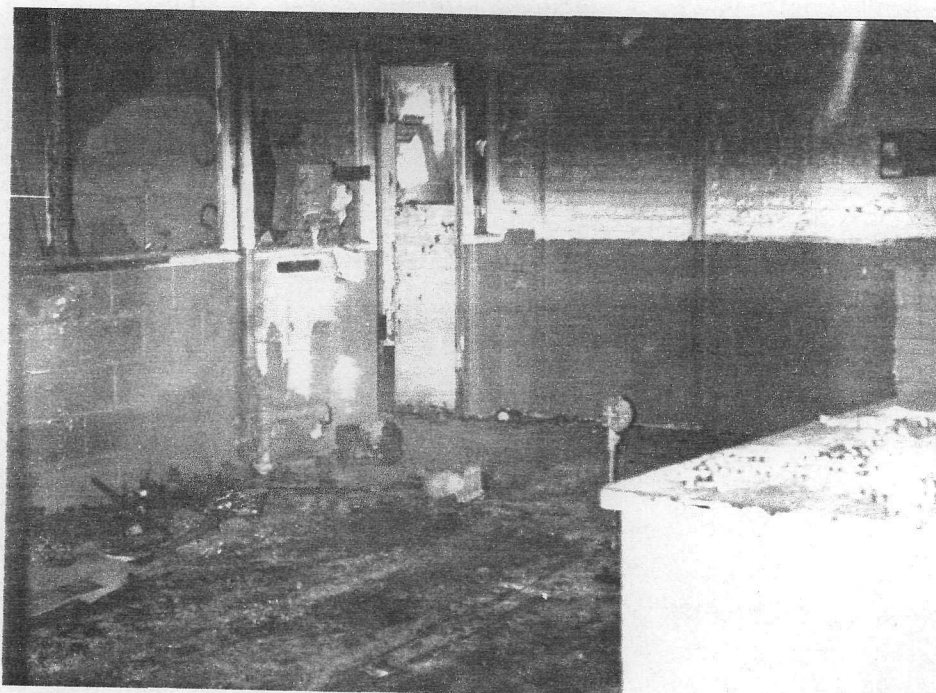
Photograph No. 93

Description: This picture shows the charred remains of a portion of the building labelled "Chemical Lab." The laboratory area was apparently located throughout the fourth floor of Building 8 and showed evidence that it had been burned at some time. Note the smoke line along the wall in the background.
